IRAQI CIVIL DEFENSE  
HEADQUARTERS  
BAGHDAD, IRAQ

**SIGIR PA-06-090**  
**APRIL 26, 2007**

SUBJECT: Report on Iraqi Civil Defense Headquarters, Baghdad, Iraq (Report Number  
SIGIR PA-06-090)

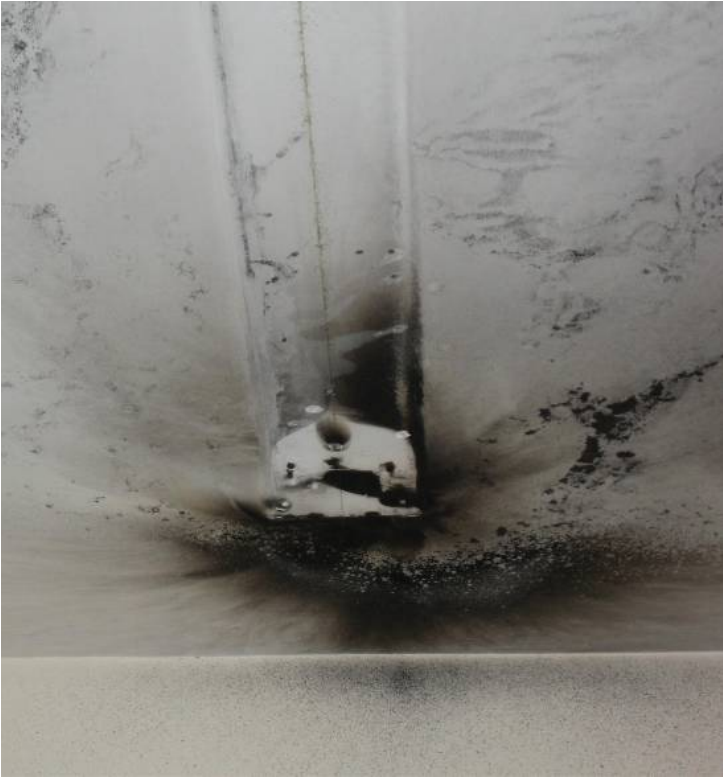
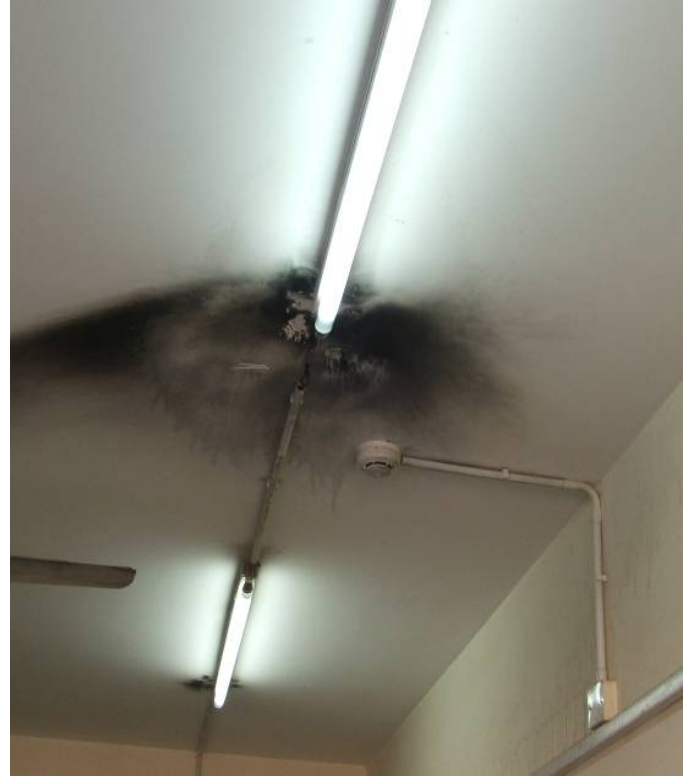
**Site Photos 44 and 45. Electrical fire damage around the fluorescent light fixtures**

Without a parts and product submittal package documenting the specific type and design of light fixture, switches, receptacles, fans, wires/conductors, and power panels installed, it is difficult to determine if the lighting fixture directly led to the electrical fires. However, during our last site visit, the GRC PE took two old light fixtures because he remembered a recent U.S. Air Force recall of certain light fixtures. The GRC PE stated he will research the matter further and determine if the subcontractor provided light fixtures were deficient; this would identify the cause of the electrical fires and possibly result in the manufacturer replacing all faulty light fixtures at the ICD HQ facility. If the light fixture is not the cause of the electrical fire, an engineering analysis will be required to determine the root cause of the fires.

1. Determine the cause of the plumbing leaks and take action to repair any portion due to deficient work on the part of the U.S. Government contractor
2. Complete the investigation initiated during our assessment to determine the cause of the electrical fires. If the light fixtures are the cause, require the manufacturer to replace all lighting fixtures throughout the facility. If the light fixtures are not the cause of the electrical fires, seek additional funding to perform an engineering analysis to determine the specific cause of the electrical fires.

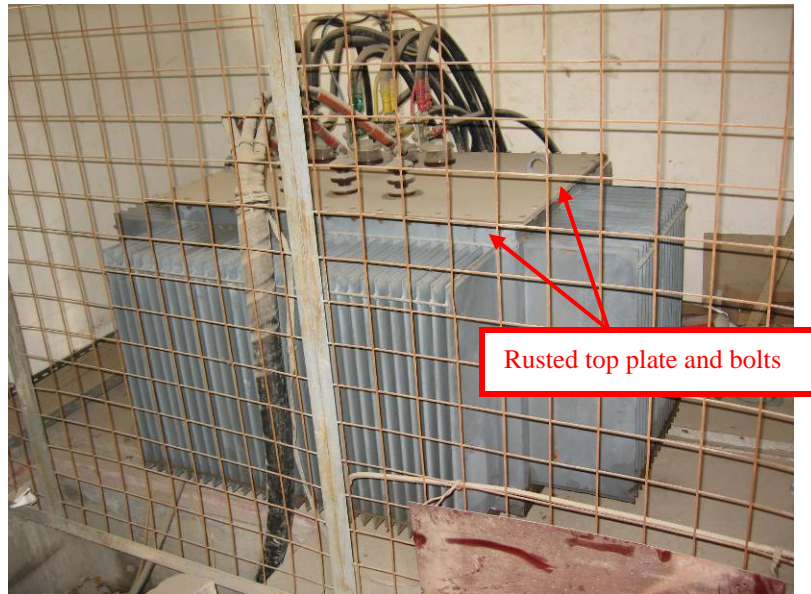
The ICD HQ personnel asserted that the faulty transformer resulted in power surges, contributing to the electrical fires. This theory does not appear to be the reason of the electrical fires. The transformer provides electrical power for the entire ICD HQ facilities, including light fixtures, ceiling fans, outlets, and computers. However, the ICD HQ personnel reported no problems with either ceiling fans or computers. Considering the amount of electrical power they draw, power surges would have a significant effect upon computers.

**Site Photo 46. ICD HQ personnel believe this is a used transformer because of its used look (rusted top plate and bolts)**

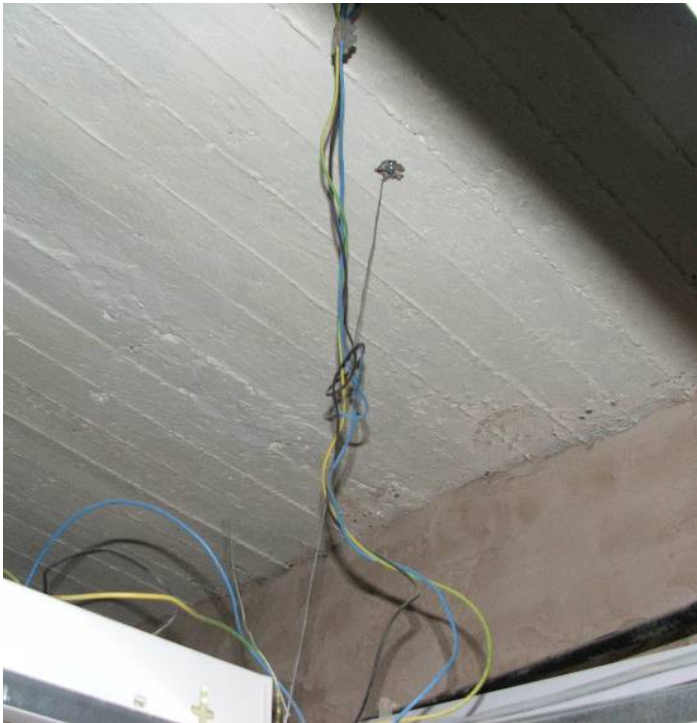
**Site Photo 47. Poor electrical installation technique (allowing wires to dangle freely from the ceiling slab)**

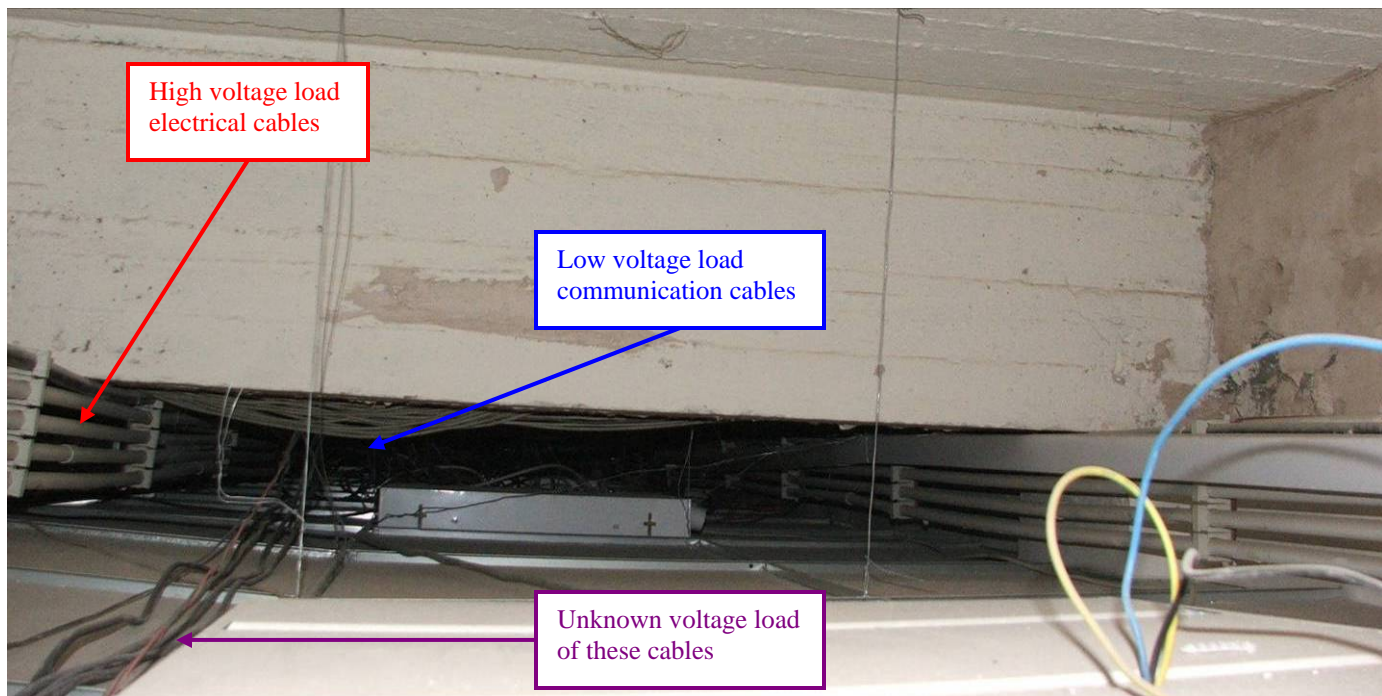
**Site Photo 49. Electrical wires carrying varying voltage loads dangerously close to each other**

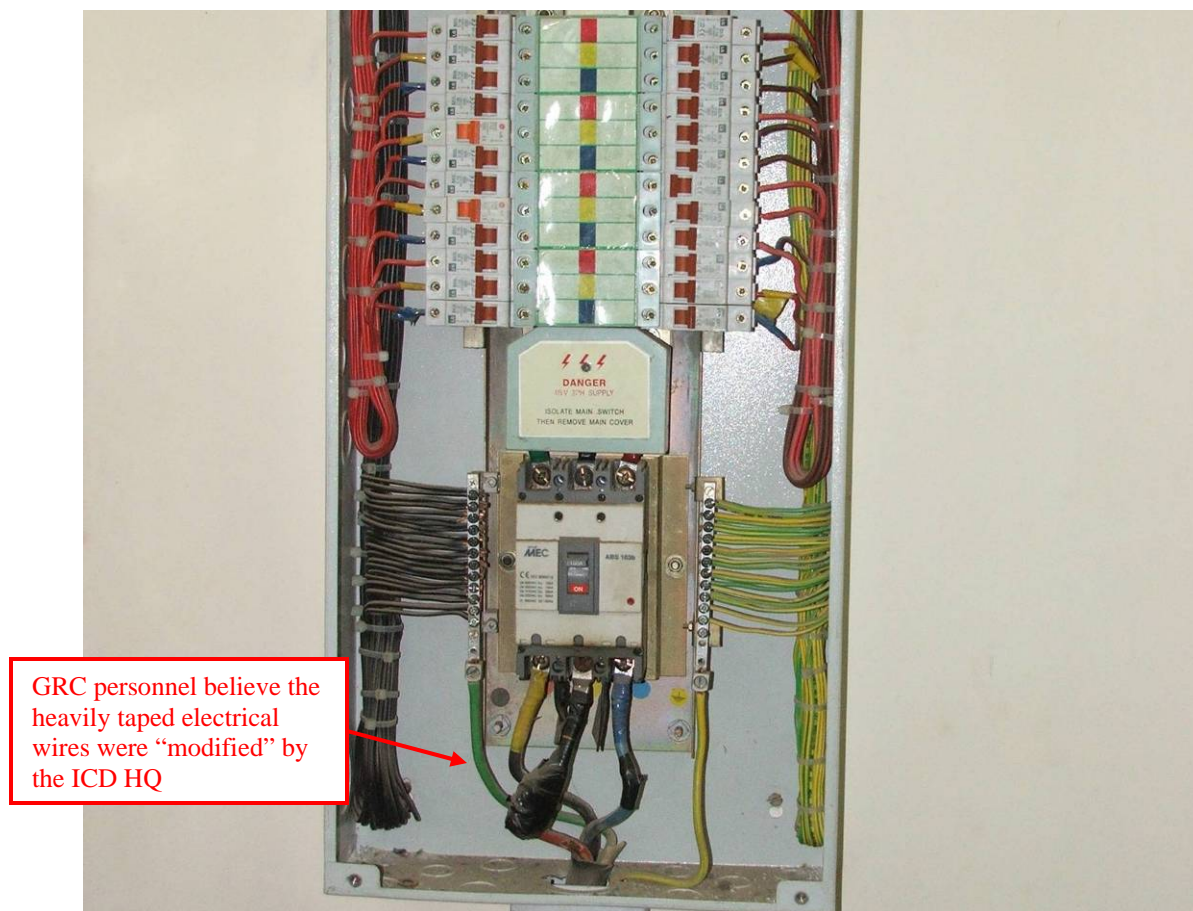
**Site Photo 50. Electrical panel GRC believes ICD HQ personnel modified**

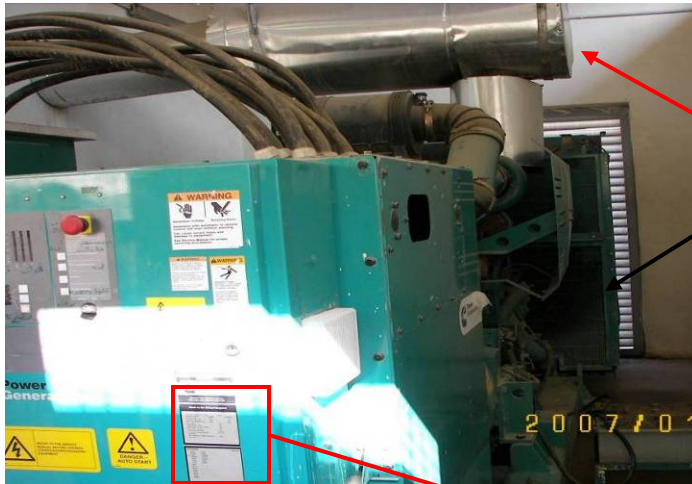
The ICD HQ personnel stated the generator overheats after approximately 1-2 hours of normal use. This deficiency has been documented in several punch-list agreements between Parsons and GRD. The ICD HQ attempted to fix the problem by adding an exhaust vent and radiator to the generator to effectively cool the generator (Site Photos 51 and 52). According to ICD HQ personnel, these add-ons have helped marginally, but the generator still has to be shut down because it will overheat. To date, according to ICD HQ personnel, the problem still has not been adequately addressed by Parsons or GRD and the ICD HQ does not have adequate power to operate essential life safety systems.

Site Photo 51. Generator power for the ICD HQ buildings

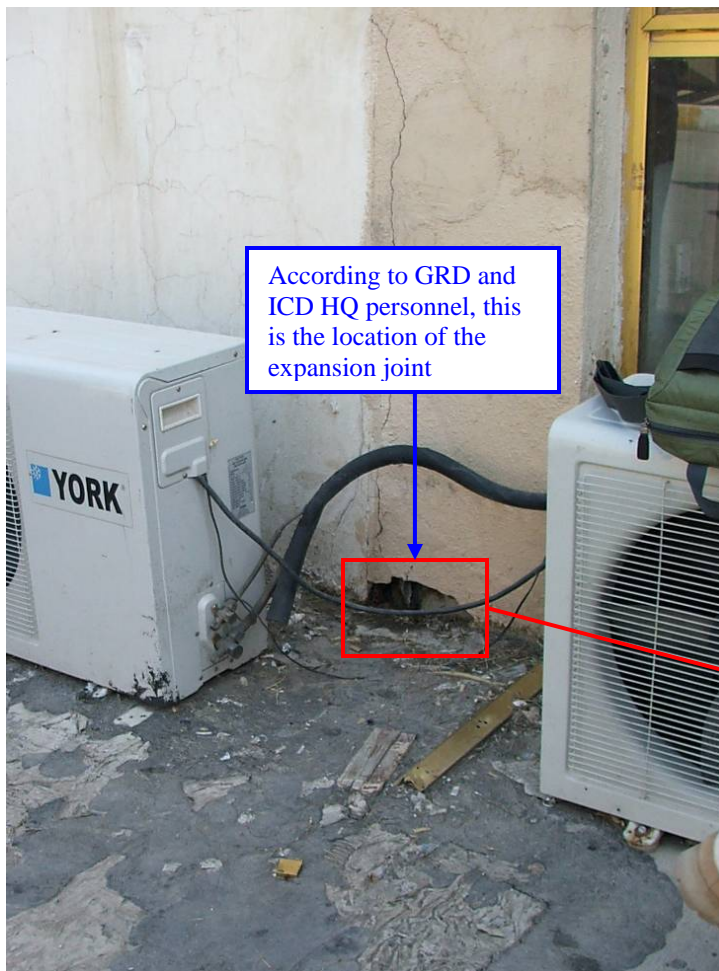
We found no evidence of the installation of any type of expansion joint system at any location in this building.

**Site Photo 58. Location of the expansion joint**

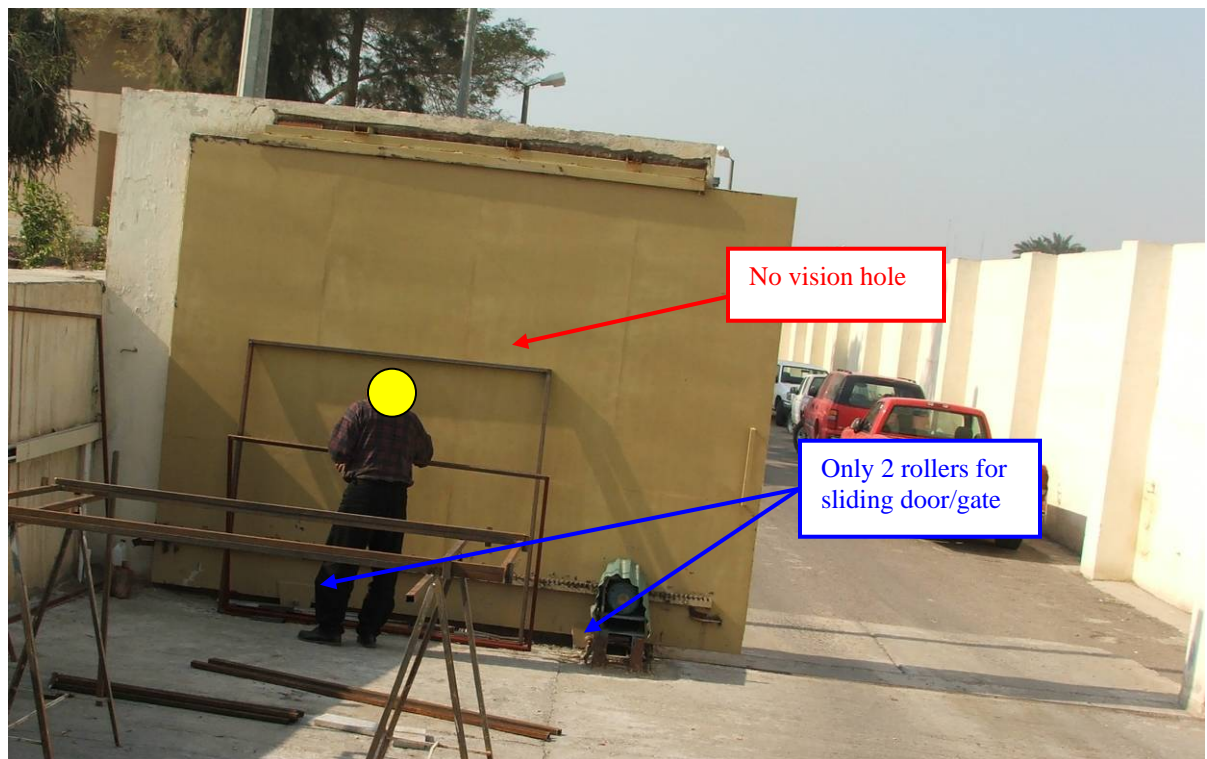
The as-built drawings for the Sally Port sliding gate indicate that each gate has four rollers/wheels and one vision hole (Figure 19). However, during our site visits, we identified that each gate had only two rollers/wheels and at least one gate had no vision hole (Site Photo 60). The lack of two additional rollers means the weight of the anti-explosive gate is distributed over two fewer wheels, resulting in additional stress on the two rollers. The vision hole is critical to enable the sliding gate guard to identify those attempting to enter the ICD HQ compound. Without a vision hole, the guard will have to partially open the sliding door in order to identify anyone approaching; this significantly increases the danger to the guard and the compound.

**Site Photo 60. Sally Port gate and motor**

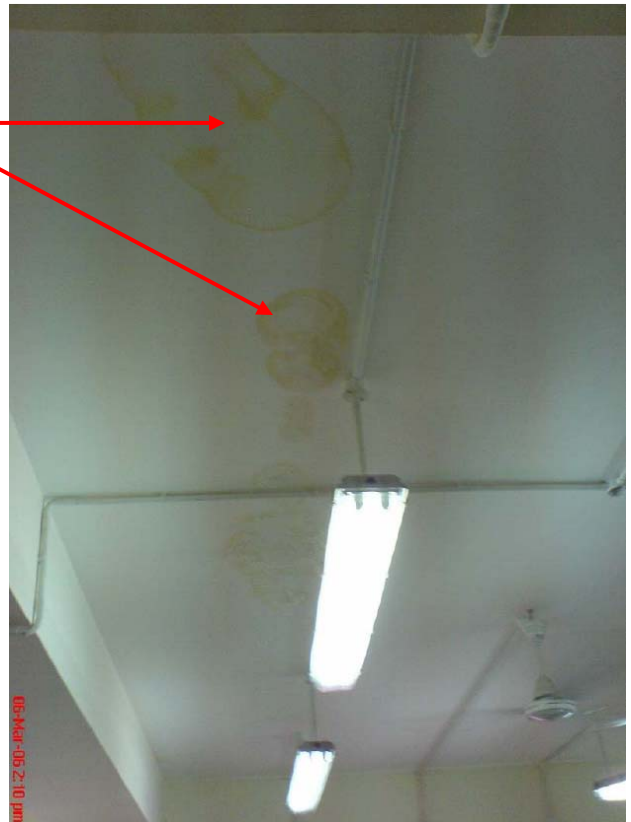
**Site Photo 64. Water damage identified in previous QA reports**  
(Photo courtesy of USACE)

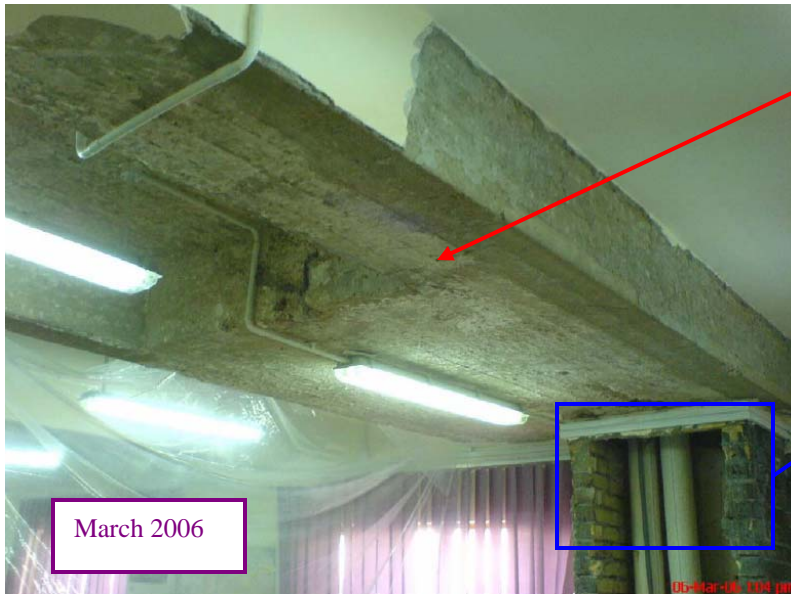
**Site Photo 65. Location of previous water damage**  
(Photo courtesy of USACE)

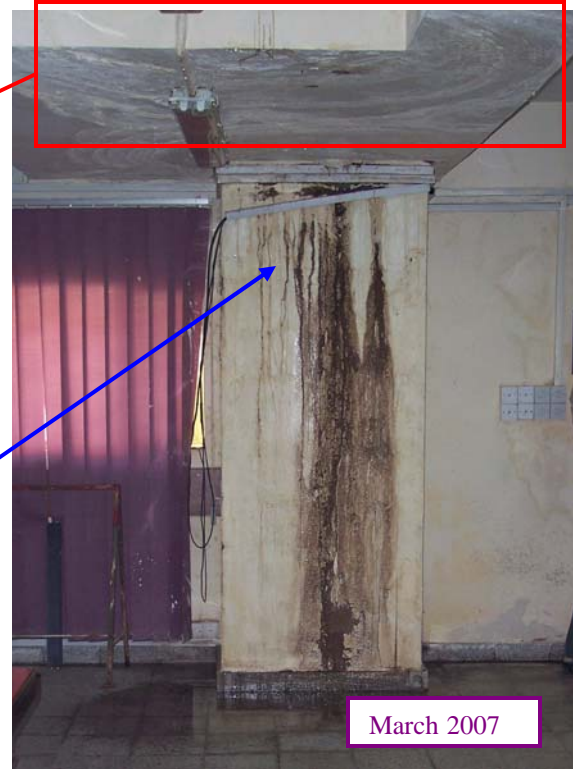
**Site Photo 66. Water damage one year later**
